GOULDSBORO DAM

PHASE I INSPECTION REPORT NATIONAL DAM INSPECTION PROGRAM

JULY 1979

GOULDSBORO DAM, WAYNE COUNTY
PENNSYLVANIA

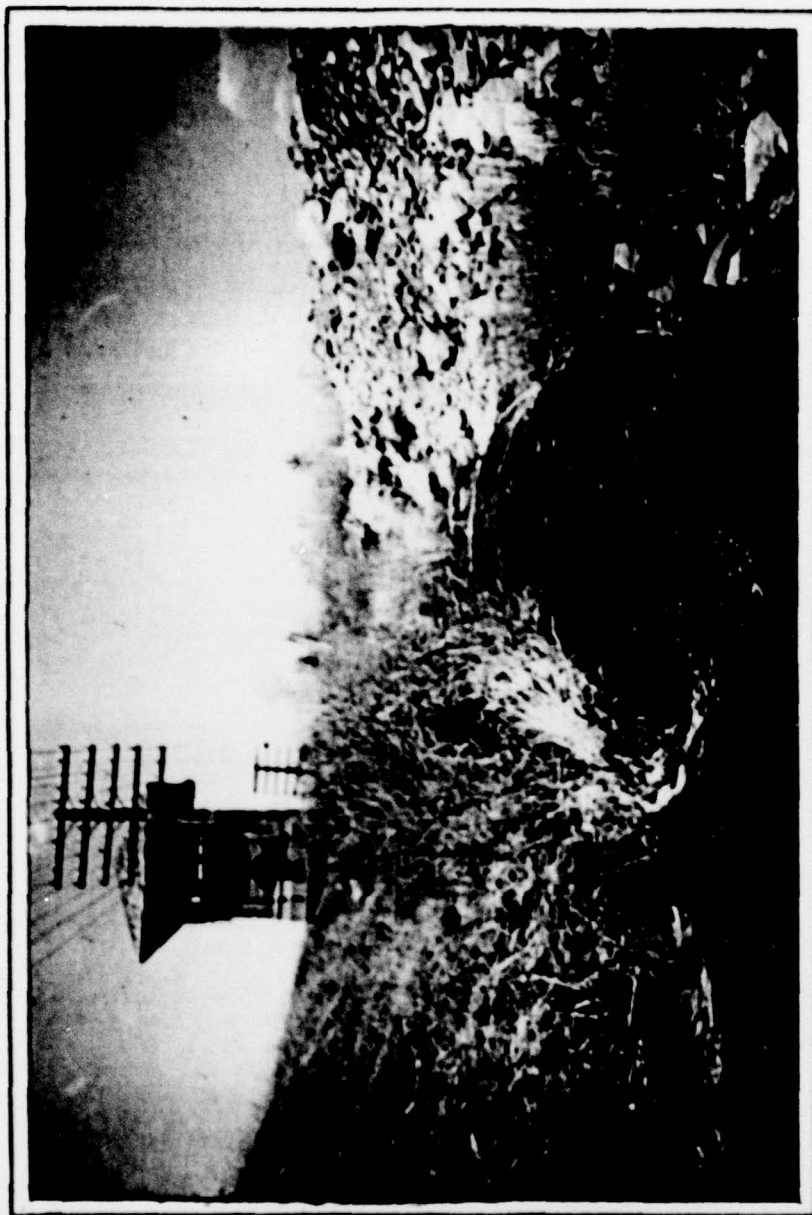
PHOTOGRAPH NO. 3

Wing walls are in fair condition with only minor spalling.
Channel is in good condition.

SPILLWAY DISCHARGE CHANNEL

2. Routine maintenance of the channel should be performed to prevent excessive brush and woody vegetation from obstructing flow.

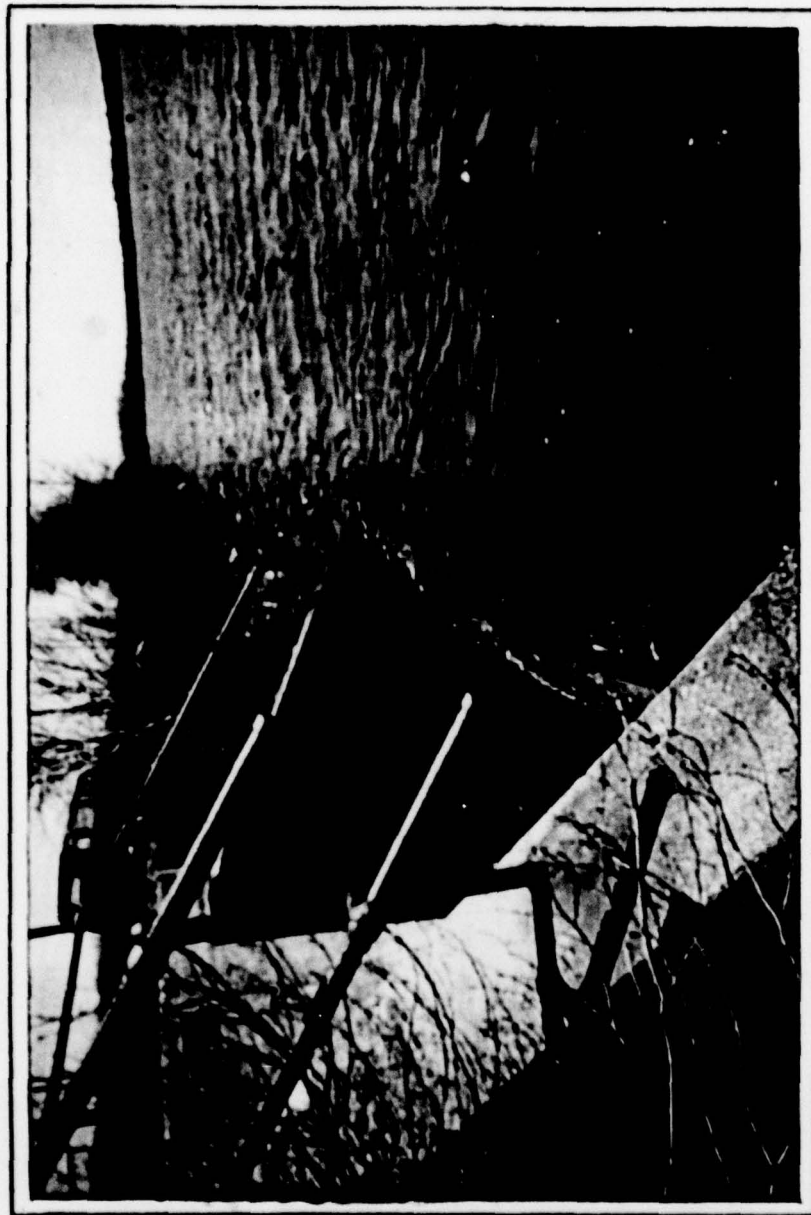
PHOTOGRAPH NO. 4

SPILLWAY OVERVIEW.

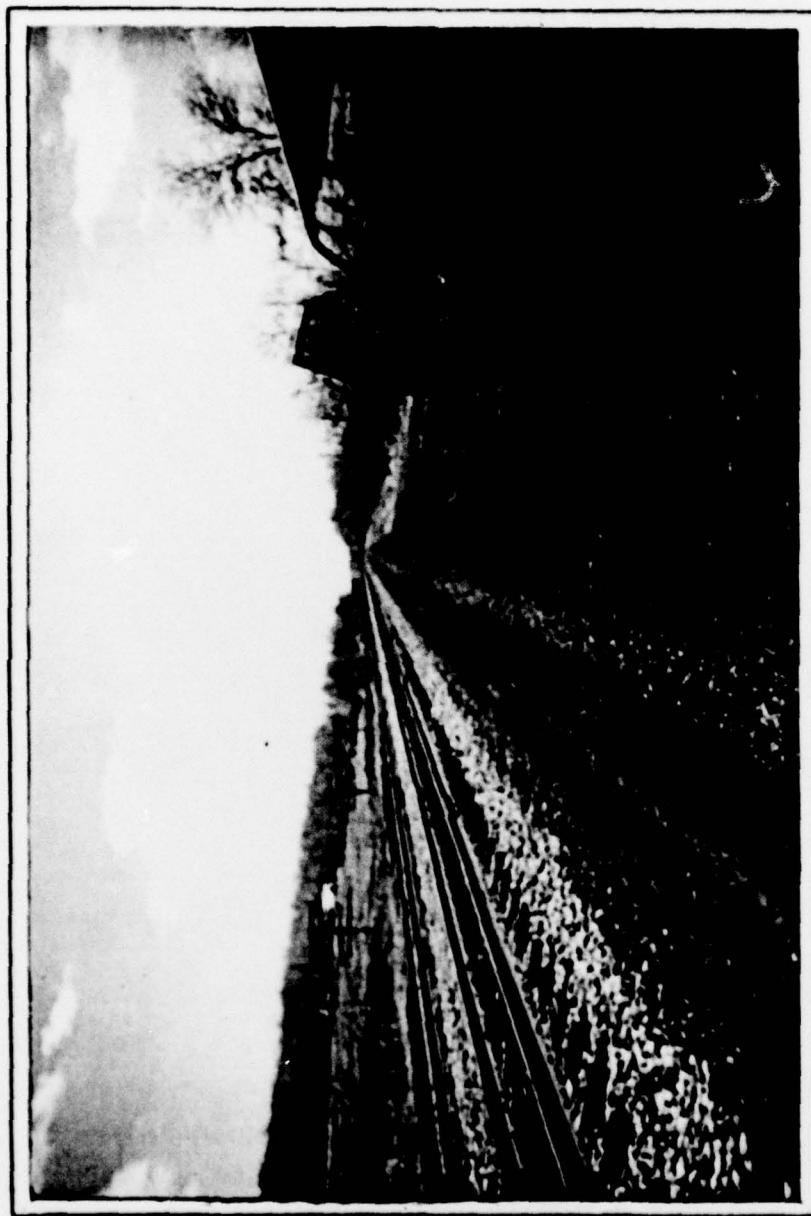
PHOTOGRAPH NO. 6

OVERVIEW OF RIGHT SIDE OF EMBANKMENT.

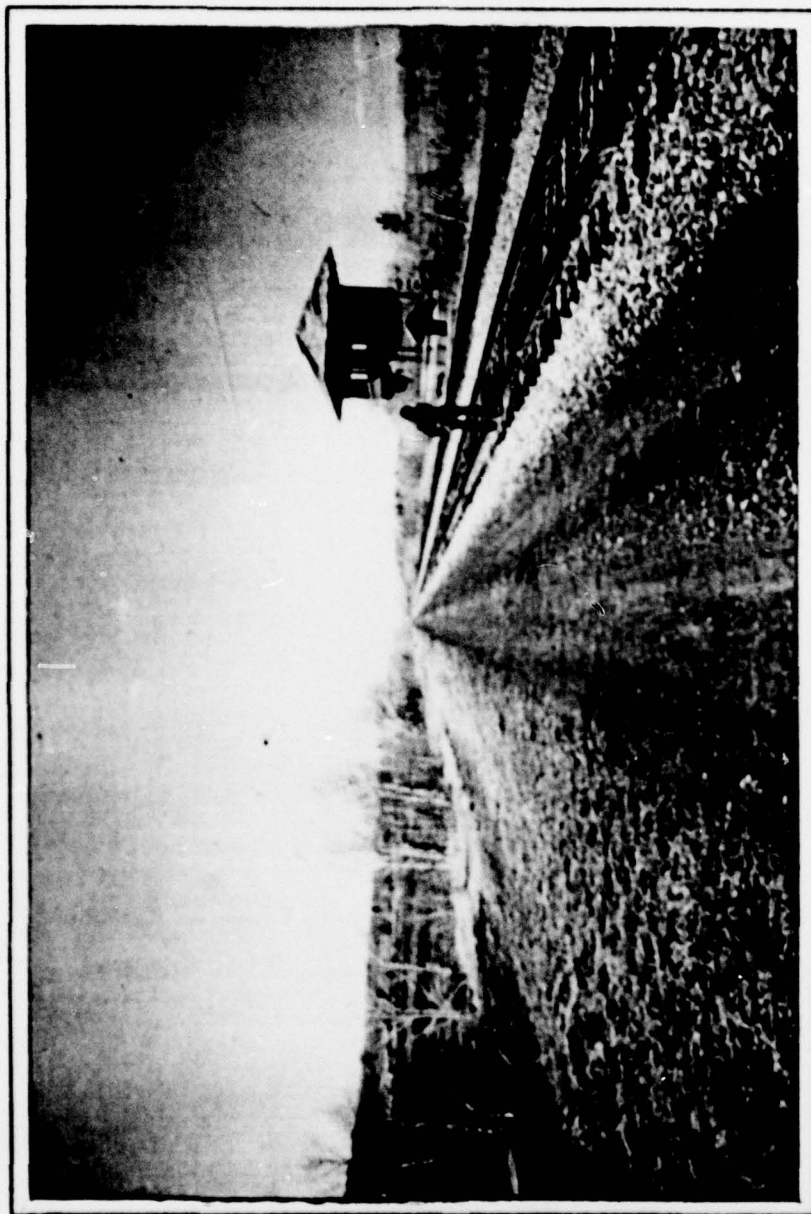
PHOTOGRAPH NO. 7

OVERVIEW OF LEFT SIDE OF EMBANKMENT.
